METALLURGICAL EXAMINATION AND MECHANICAL TESTS OF MATERIAL FROM THE POINT PLEASANT, W. VA. BRIDGE

Part 2

By
J. A. Bennett and M. R. Meyerson
Engineering Metallurgy Section
Metallurgy Division

To
Bureau of Public Roads
Federal Highway Administration
Department of Transportation

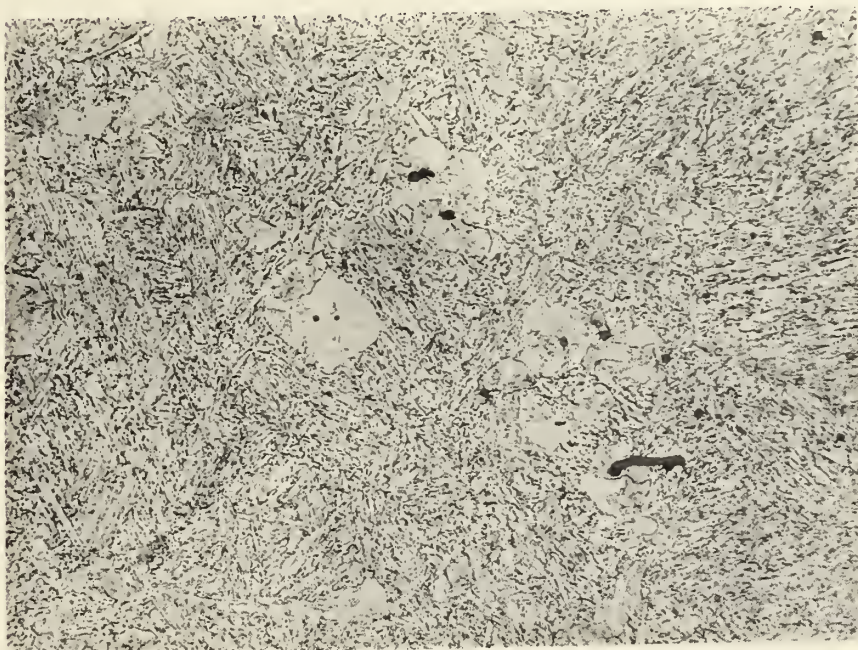
Fig. 35. Microstructure at a distance of 0.5 mm (0.02 in.) from the north face of the bar in eye C0. Hardness 212 VHN. Etched with picral. 500 X

Fig. 36. Same as figure 35, but 1.0 mm (0.04 in.) from face. Hardness 230 VHN.

Fig. 37. Same as Figure 35 but 3.5 mm (0.14 in.) from face. Hardness 245 VHN.

Fig. 38. Same as Figure 35, but 8.5 mm (0.33 in.) from face. Hardness 253 VHN.

Fig. 39. Same as Figure 35, but near the center of the bar thickness. Hardness 236 VHN.

Figures 34 - 39 show the changes in microstructure as a function of distance from the north face of the bar on a sample cut from eye C0. The results of hardness tests on the same sample are shown in figure 40, the location of the micrographs being indicated by arrows. This sample was located about three inches from the outside circumference of the eye, but samples from other locations and from the other eyes gave similar results. The principal variations observed were in the minimum hardness observed near the face and the depth at which the maximum hardness was found.

The reason for the low hardness near the faces of the eyebar was that the steel had been decarburized, probably during fabrication. The low carbon content of the surface material is shown in the micrograph, figure 34. One-half millimeter from the face (figure 35) the carbon content is much higher than at the surface, so martensite has formed, but the hardness is not as high as that at a greater depth where there has been no loss of carbon. Little difference in microstructure is seen between 1.0 mm depth (figure 36) and 3.5 mm (figure 37), although the hardness values indicate that some decarburization has occurred at least to a depth of 1 mm. At a depth of 8.5 mm (figure 38) the cooling rate was not sufficiently high to cause 100% transformation to martensite in this plain carbon steel, and intermediate transformation products are present. Figure 39 shows the structure near the mid-thickness of the eyebar where the cooling rate was sufficiently slow to produce a structure similar to that in a normalized steel, fine pearlite and ferrite.

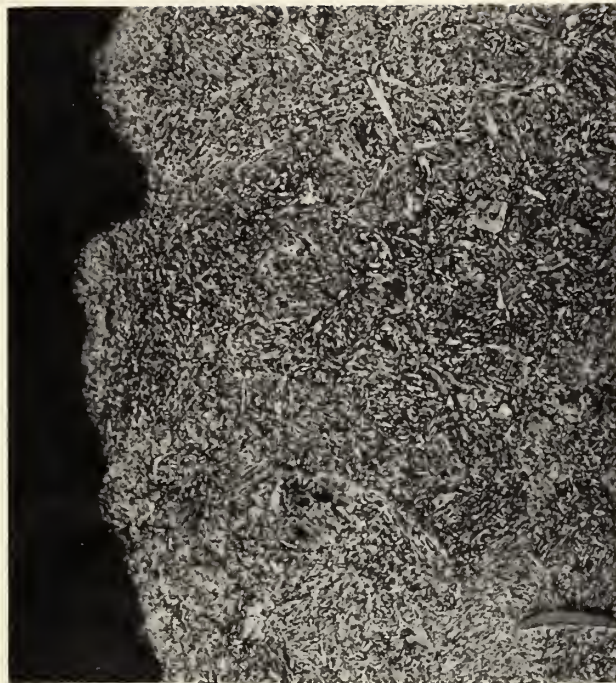
Fig. 43. Microstructure adjacent to the hole surface in eye C4, near the north face. 250 X
